# *INSPECTION REPORT*

## *LAKE HAYWARD DAM CT DEEP #04105*

HAYWARDVILLE ROAD  
HAYWARD BROOK  
EAST HADDAM, CONNECTICUT

DECEMBER 2019

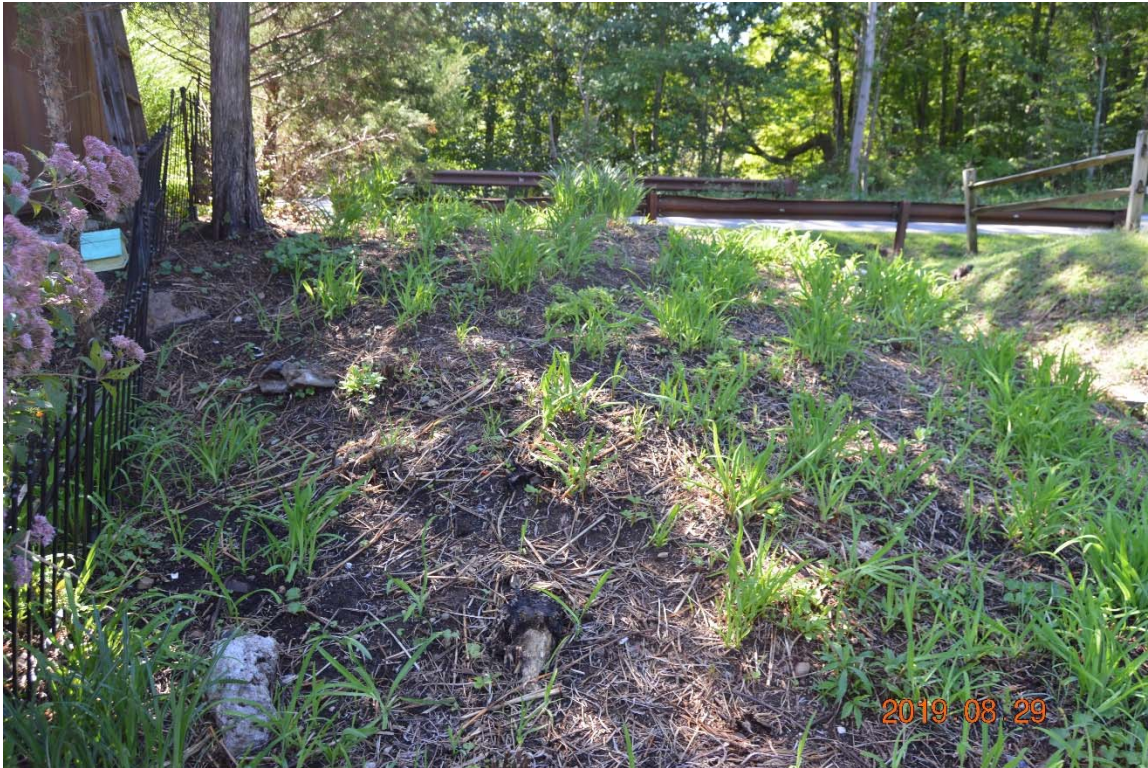
Photo 4b – The short upstream embankment section to the left of the left side spillway. Care must be taken to establish a good grass cover here.

Several small to medium size tree stumps were noted along embankment sections, from clearing as had been requested through previous DEEP inspections and correspondence. While none of these stumps present any current issues or problems, they should be monitored for any changes, particularly for signs of subsidence. Should such changes occur, an engineer should be consulted as to the proper disposition, fill materials and compaction, depending upon location on the embankments.

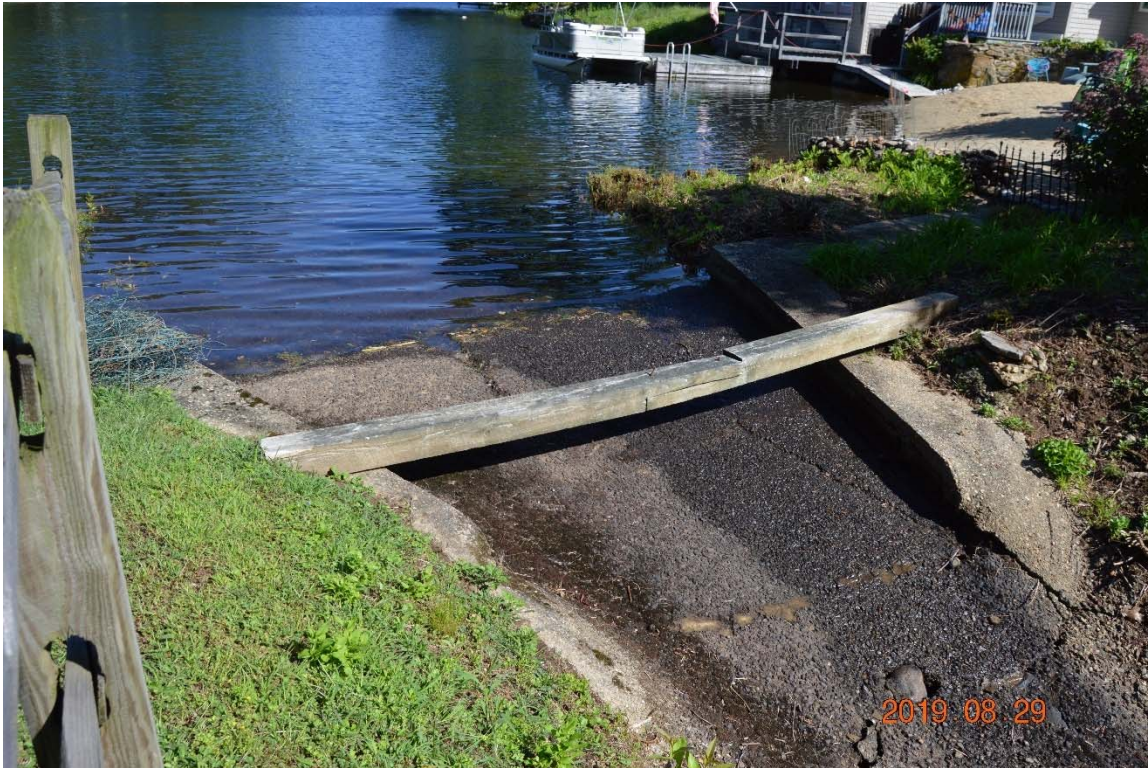
Photo 13a – The left side spillway weir.

**Cracks:** Several noted, including at the center of the upstream end of the weir, along the right training wall, and along the downstream portion of the discharge chute.

2. **Spillways & Training Walls** – Based on the hydrologic and hydraulic analysis, significant flows passing through both spillways will overtop the side training wall and shallow slope areas adjacent to the weir and channel sections. As previously pointed out, the weirs and adjacent slope areas are currently stable, but show signs of previous displacement of training wall masonry in close proximity to the weir sections. And, because this situation could lead to potential erosion of the side slopes and create debris blockage along the channels and culvert entrances, we would recommend that the weirs, the training walls and side channel slopes be reconstructed with concrete wall sections or a combination of walls and concrete filled riprap along the side slopes. This would prevent potential erosion of slopes, displacement of stones currently lining the areas adjacent to the weirs, and buildup of debris from the erosion at the culvert entrances. Temporary remedial measures would include filling in the cracks in the spillway channels and repairing displaced and undermined or eroded stone masonry.

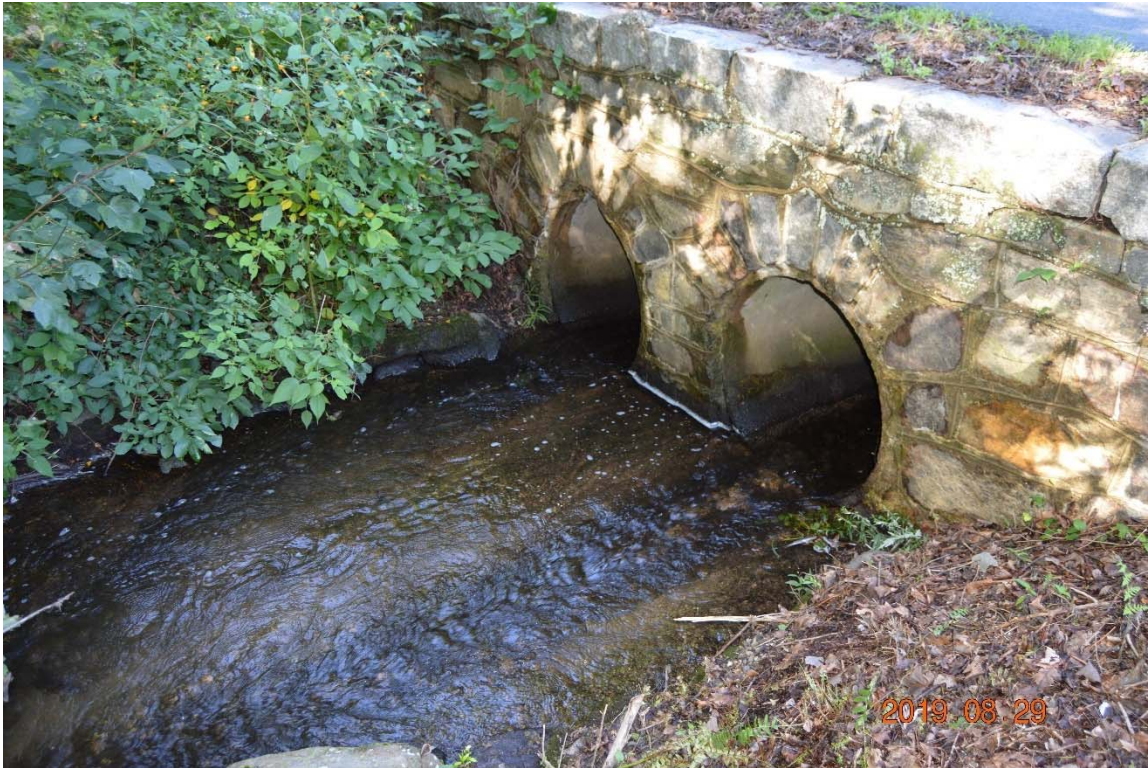
Photo 19c – The downstream end of the right side outlet pipes. The endwall is in good condition.

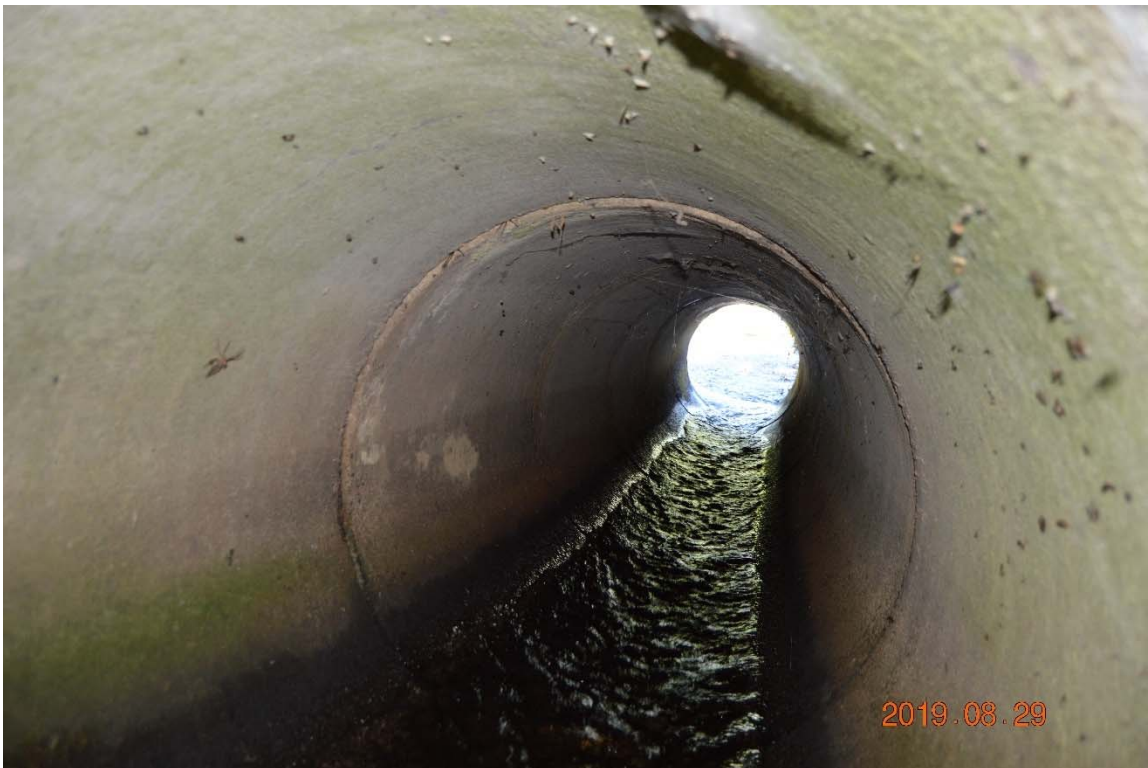
Photo 19d – The interior of the left of the twin right side outlet pipes, in good condition and representative of both pipes.

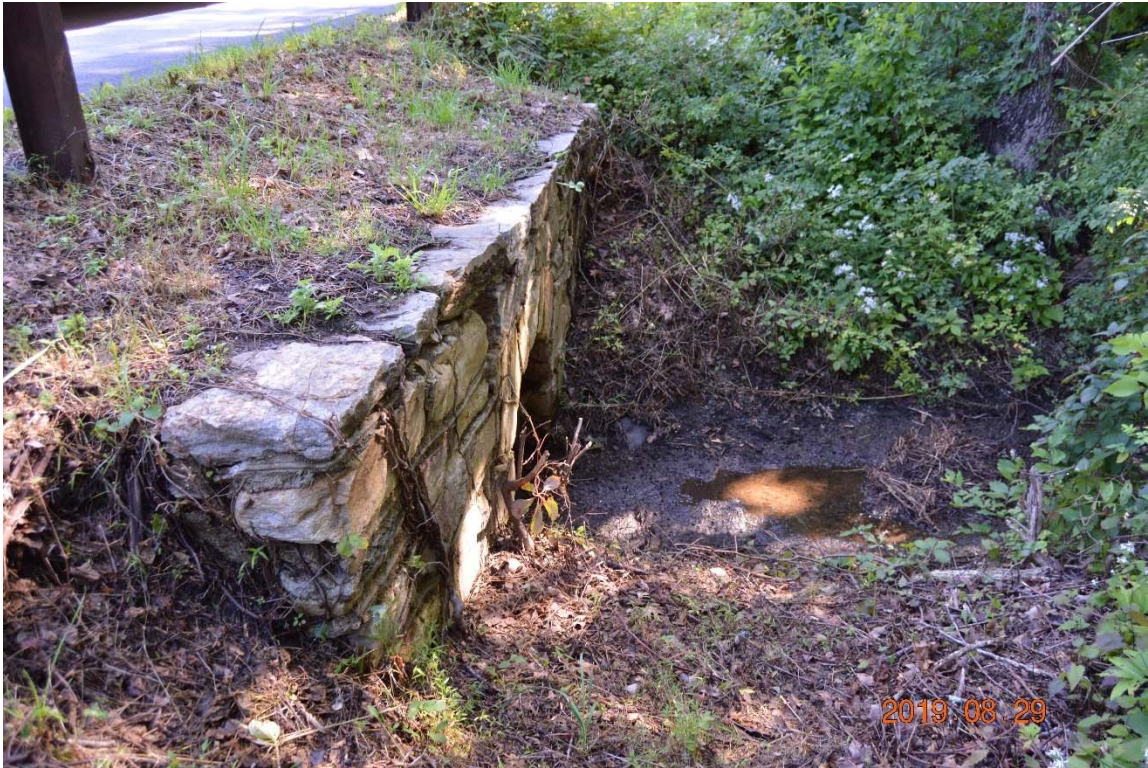
Photo 19e – The downstream end of the left side outlet pipe. This endwall is also in good condition.

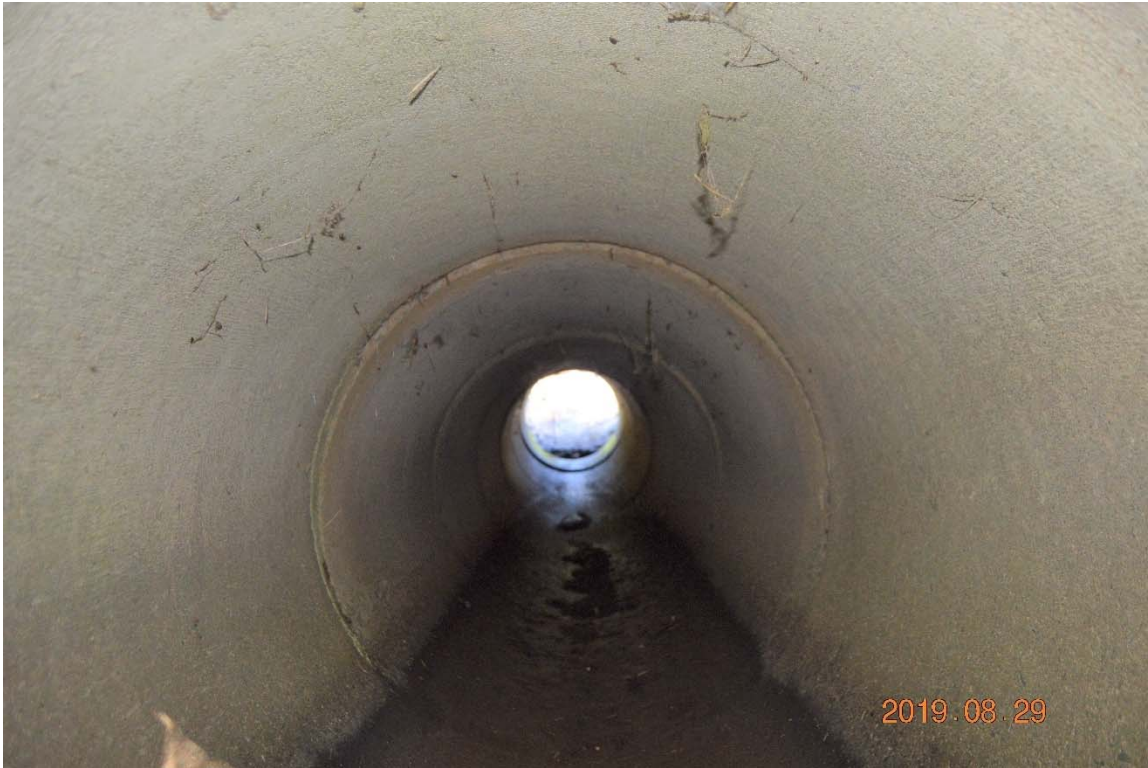
Photo 19g – The interior of the left side outlet pipe, in similarly good condition to the two right side pipes.

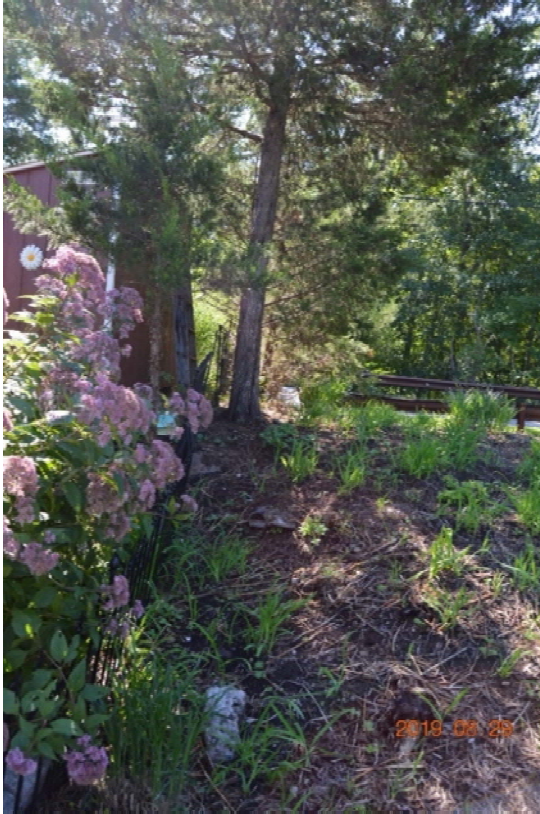
Photo 21a – The upstream side of the left embankment, most of which was cleared of vegetation along the slopes after the first inspection. Dense and woody vegetative growth should continue to be removed, and a sound grass cover established and maintained.

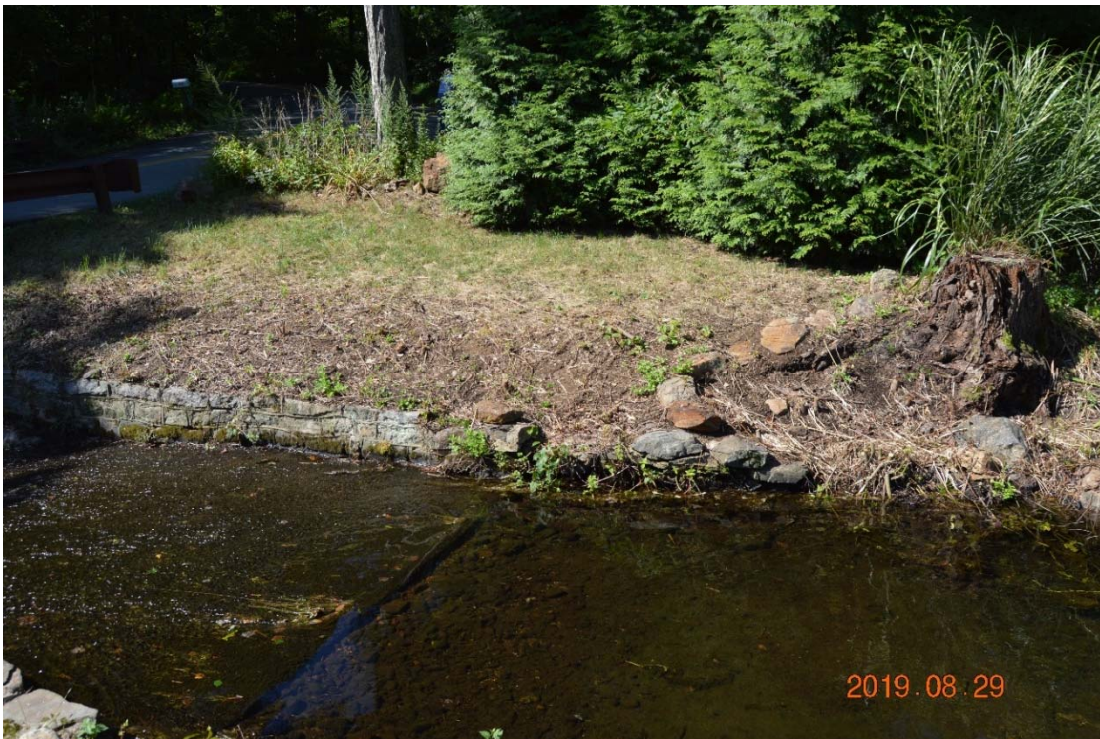
Photo 21b – The embankment along the right side of the right discharge channel. This area was recently cleared of brush and vegetative growth, and should have a grass cover established and maintained. The tree stump (from previous clearing) must be monitored and any depression resulting therefrom filled in as required if subsidence should occur. In the event of reconstruction of the training wall area, the stump and roots should be removed at the same time. The training walls in this area have deficiencies that require improvements and repairs.

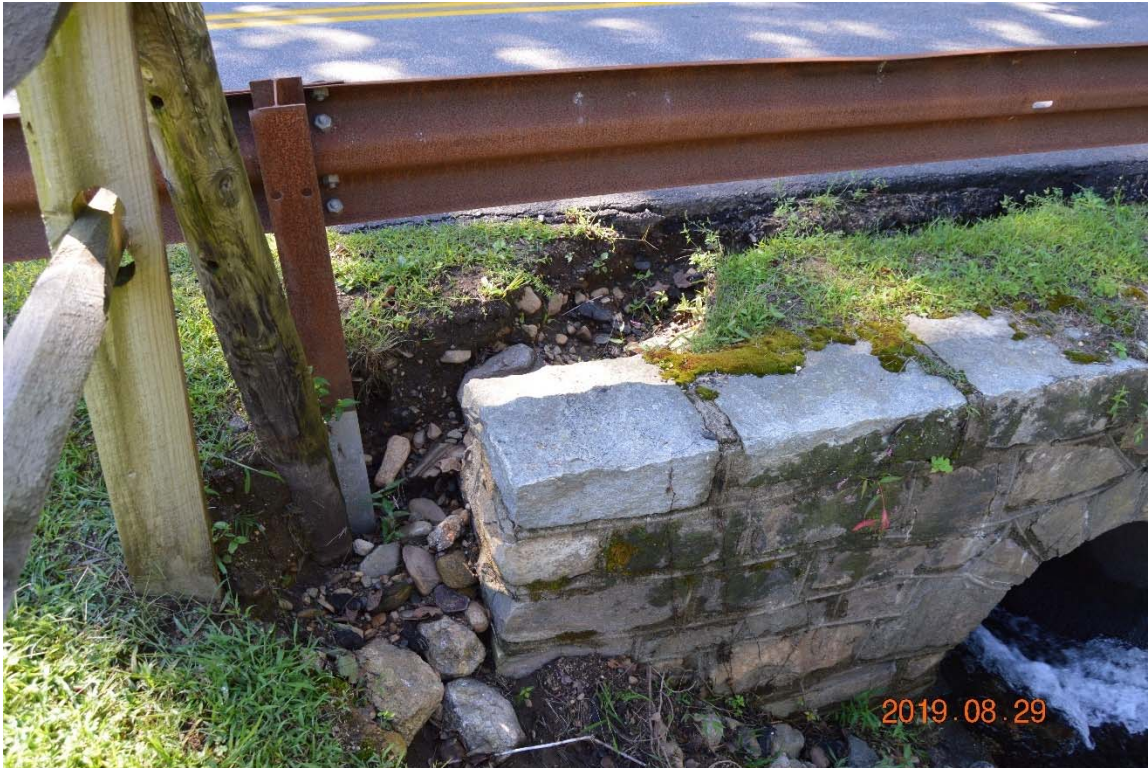
Photo 21c – An area of washed out soil, caused by runoff from Haywardville Road, running around the right side discharge culvert endwall at the time of inspection. This area was subsequently repaired (see below).

4. **Roadside Erosion at the Right Upstream Headwall** – The erosion shown in the photographs at this location was recently (i.e., subsequent to the inspection of the dam) repaired with the placement of asphalt in the eroded flow channel. While this is a temporary fix, it is not considered a long term solution. We would encourage the Town to install a catch basin near the low point area of the erosion problem just west of the headwall and then divert flow through a piping system to the downstream channel. This will avoid flow at the headwall altogether and avoid additional flow on the inlet side of the culvert. Long term repairs can then be combined with the recommended improvements to the discharge channel training walls noted in No. 2, above.

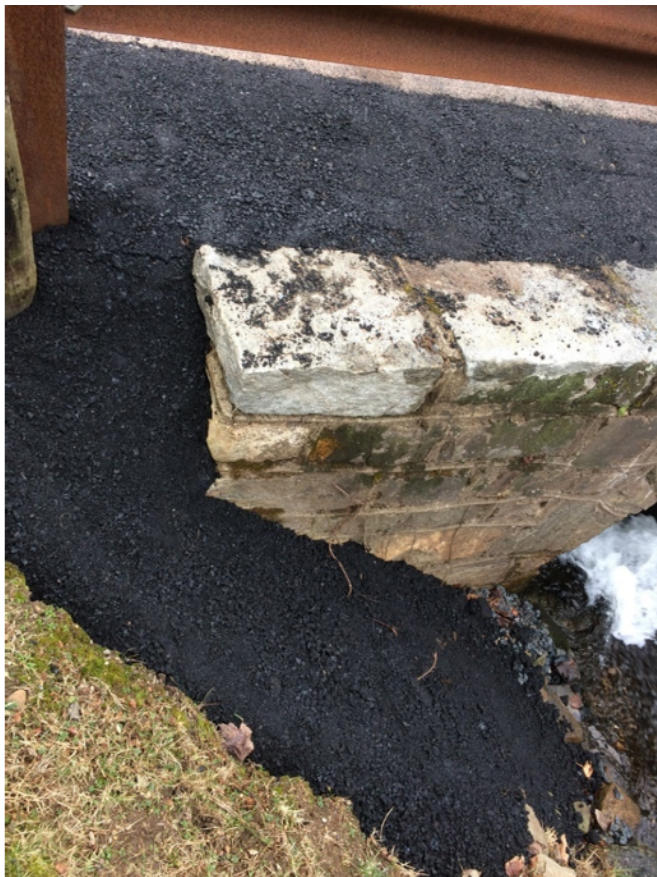
Photo 21d – The same area as the previous photo after placement of surficial asphalt in the eroded area. See the long term recommendations in the preceding sections.

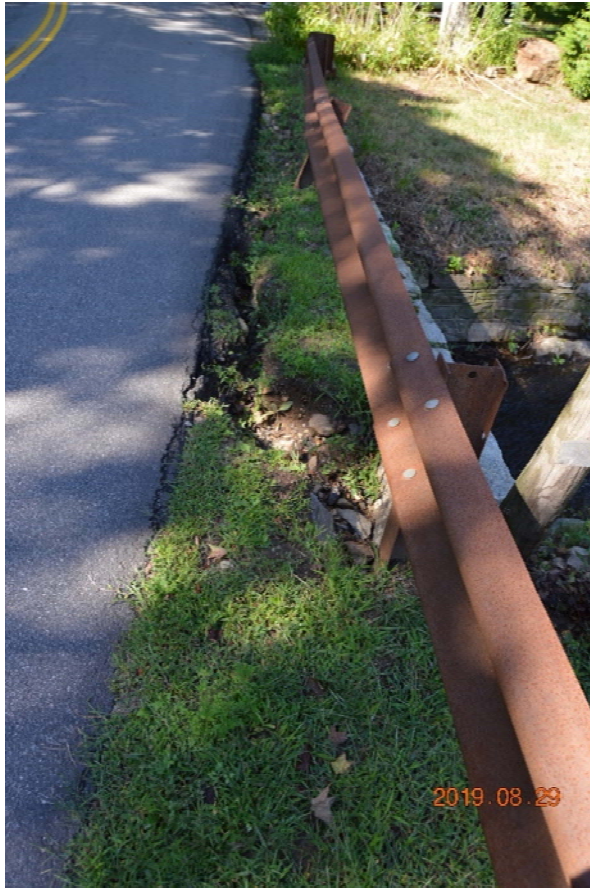
Photo 21e – Looking westward toward the source of the erosion shown in the prior two photos. There is no curb or other implement to direct drainage flowing downhill along the road away from the grassed area at the low point near the endwall.

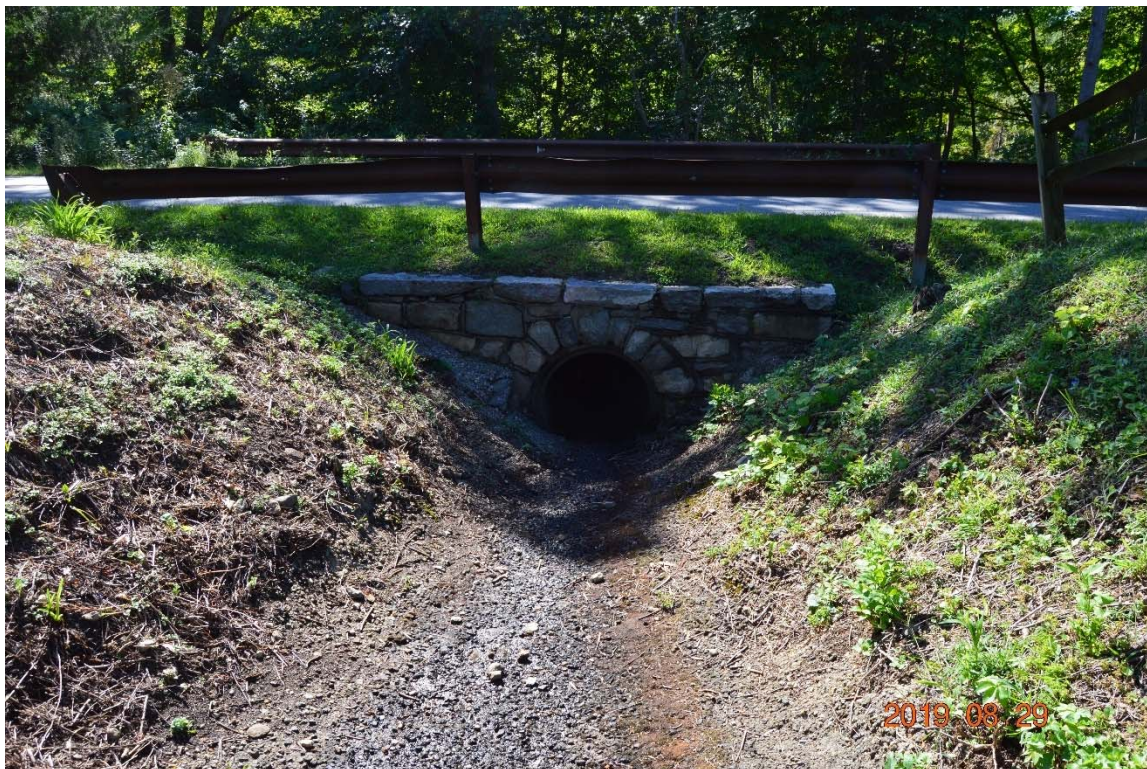
Photo 21f – The lower portion of the left discharge channel. Side slope areas where brush growth was recently cut must be kept cleared with the reestablishment of a grass cover to prevent erosion during high flow situations. (See Section XII for additional long term recommendations.)
