# LAKE HAYWARD WATERSHED MANAGEMENT PLAN

January 2021

*Prepared by the Lake Quality Improvement Committee of Lake Hayward  
With Technical Contributions from SLR International Corporation (formerly Milone & MacBroom, Inc.)*

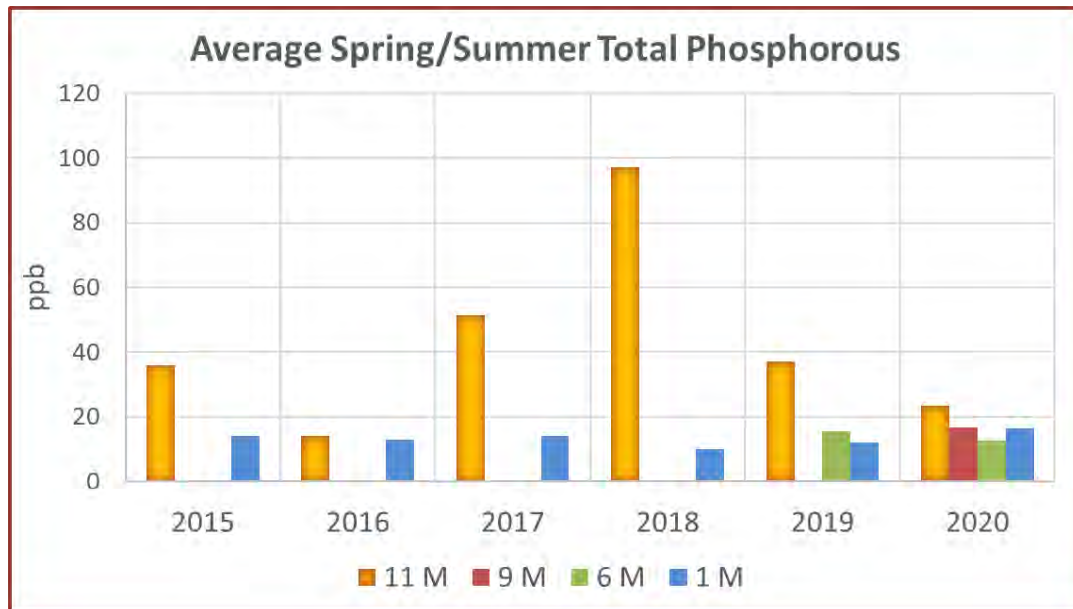
FIGURE 3-2

Phosphorus can be present as dissolved or particulate and organic or inorganic-bound forms. Studies in this region have focused on total phosphorus (TP) rather than individual fractions. This is in part to simplify sampling and analysis but also because phosphorus has been shown to transition between phases. In 2015, LQIC began monitoring surface and bottom water samples for TP collecting samples with a van Dorn sampler and delivering to an analytical lab for analysis. This was expanded in 2019 to increase the frequency of sampling and to add intermediate depth samples. Figure 3-2 shows sample results for these years. The surface phosphorus has not changed significantly, but the bottom samples are highly variable.

The higher phosphorus concentration from water sampled at 11 meters is due to accumulated phosphorus in anoxic water. In the summer, the development of density differences due to temperature stratification keeps the bottom water separate from the surface waters and is no longer in contact with the air. Decomposition in the sediment consumes oxygen that can eventually create anoxic waters in the hypolimnion. Since phosphorus is soluble in anoxic water, any phosphorus that comes out of the sediments or is precipitated from the water column above will generally remain in solution. Together, these two processes account for the higher accumulation of phosphorus in the bottom layers. Herbicide treatment also may increase oxygen

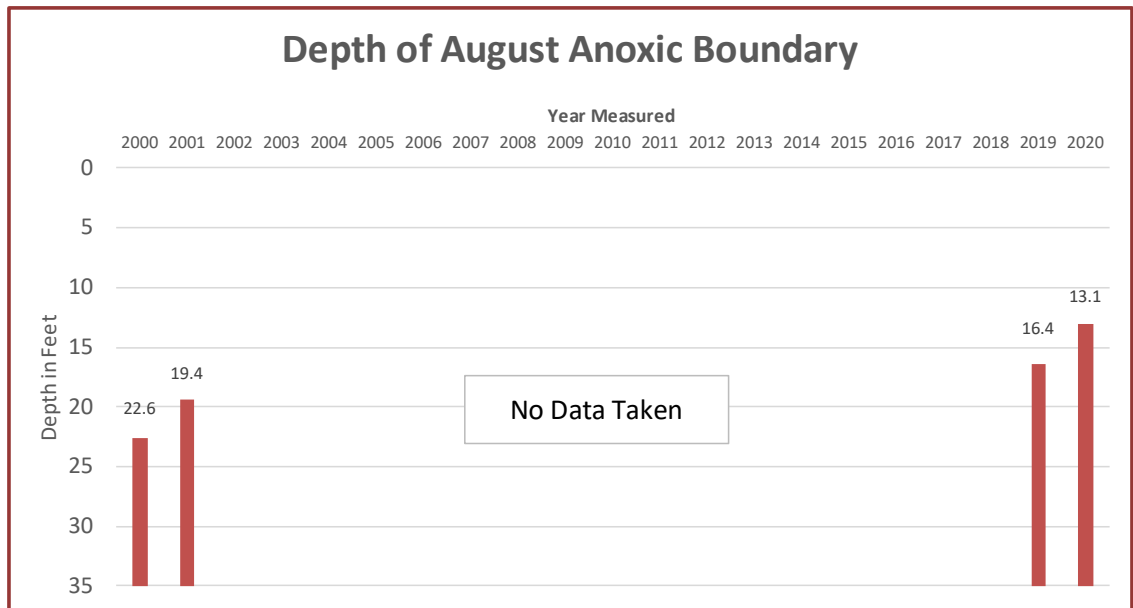
**FIGURE 3-7**

Figure 3-7 compares the height of the August anoxic boundary in 2019 and 2020 with prior sampling done in 2000 and 2001. The height of the anoxic boundary is clearly higher now than it was in 2000/2001. Anoxic water promotes a number of chemical reactions in the bottom sediments that release nutrients including nitrogen, phosphorous and ammonia from the lake bottom. The higher the anoxic boundary, the more severe anoxic conditions can be expected lake-wide.

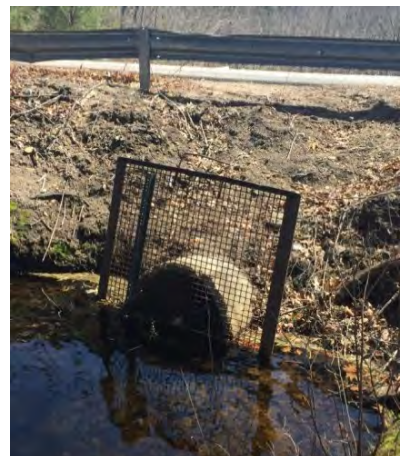
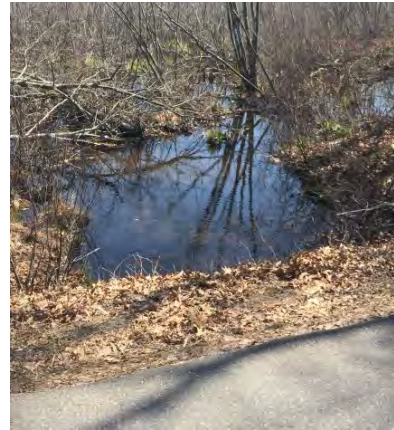
The culvert beneath Lake Shore Drive is a ±36-inch concrete pipe that conveys water beneath the road and hydraulically connects the main lake to the back water. The upstream end of the culvert (shown in the top photograph to the right) has

been fitted with a steel grid trash rack. The downstream end of the culvert (shown in the bottom photograph to the right) discharges into a backwater scrub area of the lake. The pipe is oriented such that it is directed towards the bank. Some undercutting of the bank is evident but is not severe. The pipe is supported by a rock retaining wall that is in fair to marginal condition. Water was running clear on the day of inspection (4-17-16), with no evidence of sediment contamination. This is expected, as the area north (upstream) of Lake Shore Drive acts as a sediment forebay to the lake.

Based on the lack of visible water quality issues, erosion and/or accumulated sediment, this sub-watershed is considered to be a low priority area relative to stormwater quality impacts. This is largely due to the very low density of development within the sub-watershed and the impounded area upstream (north) of Lake Shore Drive that acts as a sediment forebay. The biggest threat to this sub-watershed is the potential for future development. This is discussed more fully in Section 7. Minor erosion on the right bank of the downstream end of the N-1 culvert should be monitored for signs of significant deterioration.

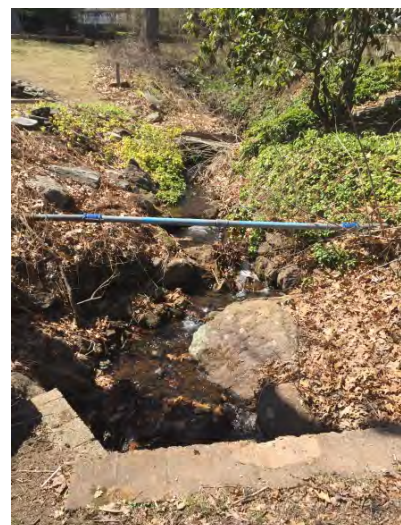
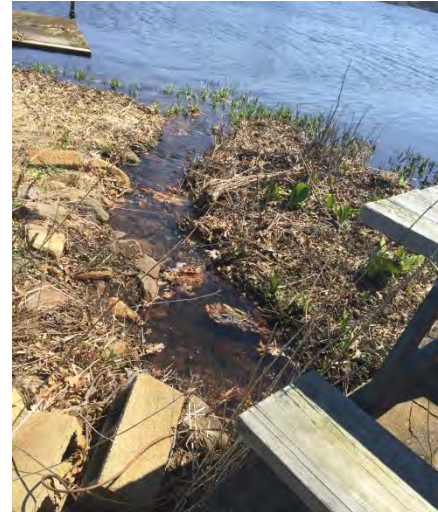
A steep flow channel only several feet wide conveys water during the wet months and following rainstorms down the hill and to a 24-inch corrugated metal pipe that flows beneath Lake Shore Drive. The pipe has a mortared block headwall on both the upstream and downstream ends. A metal pipe spans the flow channel upstream of the culvert beneath Lake Shore Drive (shown in the left-hand photograph). Its purpose is unknown.

The downstream end of the outfall at W-1 flows beneath a lawn area and then discharges into the lake. A sizable vegetated delta has formed at this outfall, likely having developed over decades following the initial development around the lake and the subsequent formation of the incised drainage channel from the hill. Water that discharges from this outfall flows through a small channel that runs through the delta before discharging into the lake. The substrate is a mix of sand and small cobble and the outfall pipe is free of accumulated sediment.

This sub-watershed is considered to have moderate priority relative to stormwater impacts. Future efforts should focus on the stability of the flow channel and maintenance of a free flowing outflow at the decades-old delta. As with other sub-basins, future stormwater management efforts in this sub-watershed should include resident education and voluntary stormwater management practices.

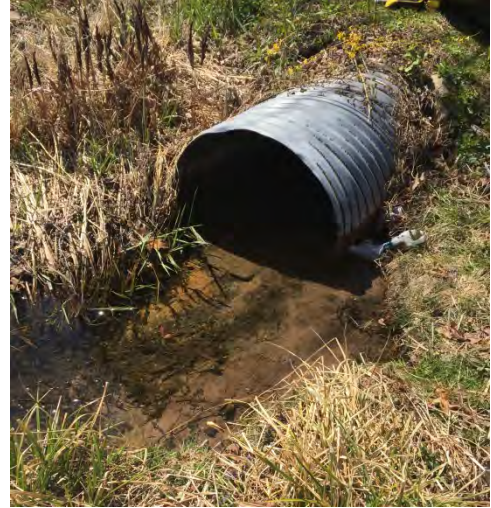
path at the outfall may have been manually dug out at one time to maintain an open flow path. The pipe is partially clogged with sediment, with approximately three-quarters capacity remaining. This outfall was cited as one of the top 6 priority outfalls identified in the 2012 study Stormwater Management Study as was a second outfall immediately adjacent to it, which is no longer visible. Upon closer inspection, this pipe has been partially squashed, is more than half full of sediment, mostly underwater, and no longer functioning.

Given the high degree of sediment accumulation, the densely developed area draining to this outfall, and its proximity to a public bathing beach, this sub-watershed is considered to have high priority relative to stormwater impacts. Frequent catch basin clean-out, public education and implementation of volunteer stormwater management, and construction of a bio-detention or bio-infiltration basin are recommended.

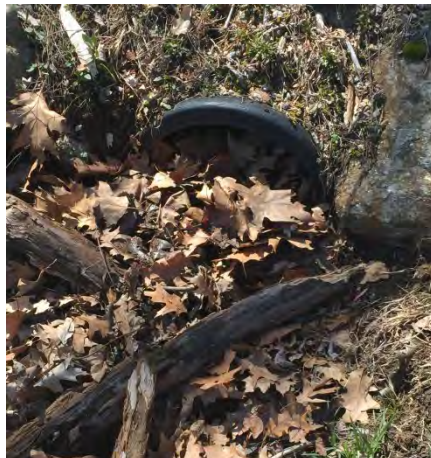
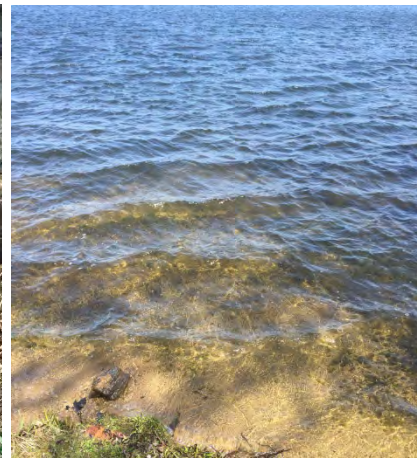
A 12-inch corrugated plastic pipe outfall pipe is visible but completely clogged with sediment, leaves, and debris (see left-hand photograph to the right). This outlet is not functioning at all. The upstream catch basin on Lake Shore Drive has been observed to have standing water and may

be vulnerable to flooding during high intensity or prolonged storm events. The shoreline in the area of the outfall shows evidence of historic sediment accumulation and formation of a delta that extends well into the lake.

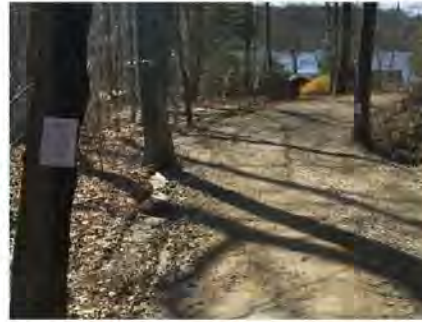
**EXISTING WASHOUT PHOTO**

A cross culvert and energy dissipator is recommended within this sub-basin to provide a less destructive and a more erosion resistant method of draining water from the east side of East Shore Drive to the west. On May 11, 2016, representatives of the LQIC met with representatives of the Town of East Haddam to discuss potential solutions to this ongoing source of sediment to the lake and a winter hazard when the road becomes covered in a sheet of ice. The Town concurred with the LQIC recommendations and stated their intention to pursue an easement with the landowner on the lake side of East Shore Drive to enable construction of the remedial measures by town forces. Below is a schematic drawing of the solution.

nowhere to go but up, over, and across the road towards the lake. This condition has existed for a number of years, causing the road to wash out during particularly wet conditions and form a sheet of ice during wet, cold conditions in the winter.

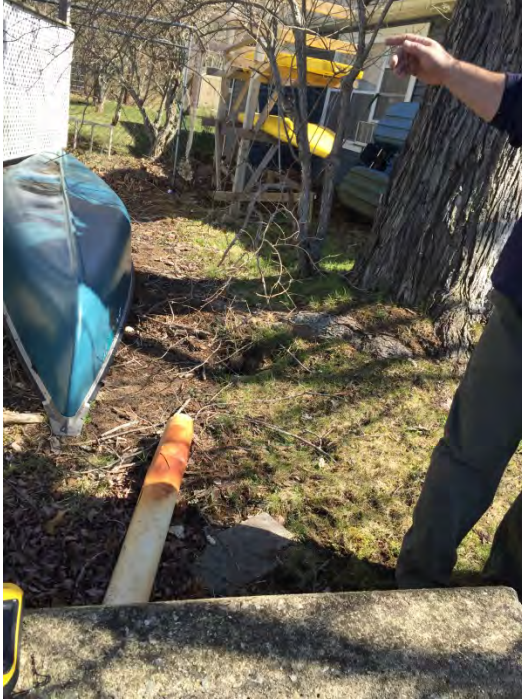
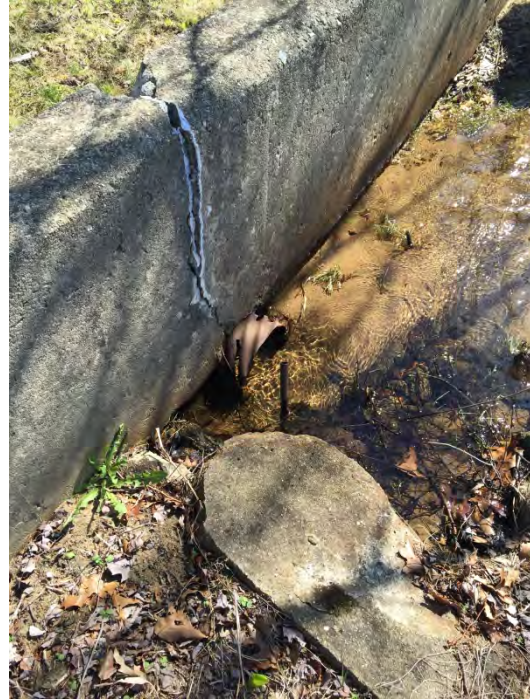
The final crossing within sub-basin E7 occurs near East Shore Drive and has been observed actively flowing, following significant periods of rain. The flow in this area from the road to the lake occurs in a circuitous path, crossing beneath several low-lying plank footbridges, along a stacked rock wall and through a wooded area. Eventually, this stream joins several other localized flow paths and eventually discharges into the lake through a galvanized pipe that flows adjacent to several cottages.

The pipe discharges through a cracked concrete wall into the lake. The pipe is half submerged into the lake sediment and appears to be only marginally operational.

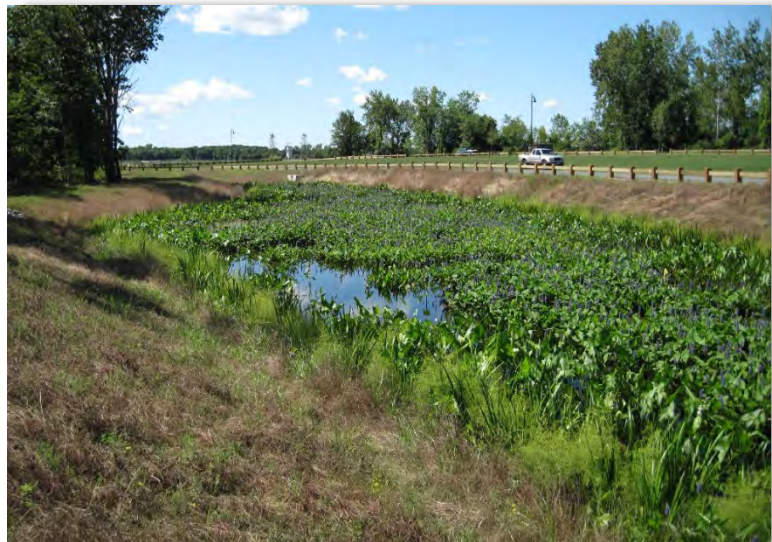
Example of a Water Quality Detention Basin

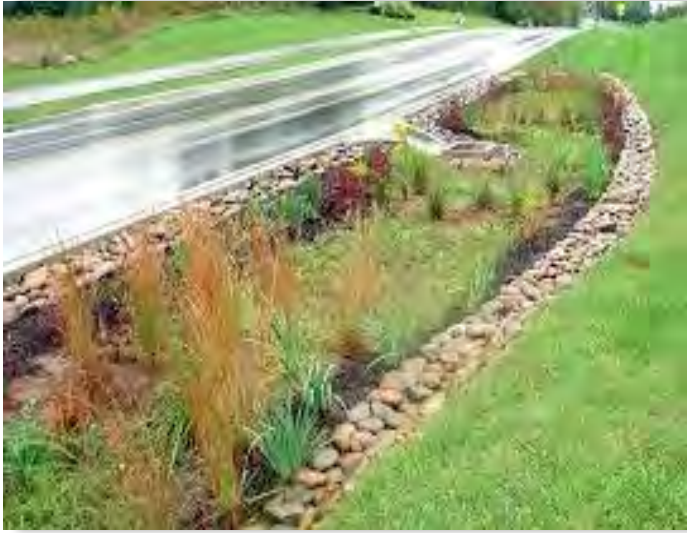
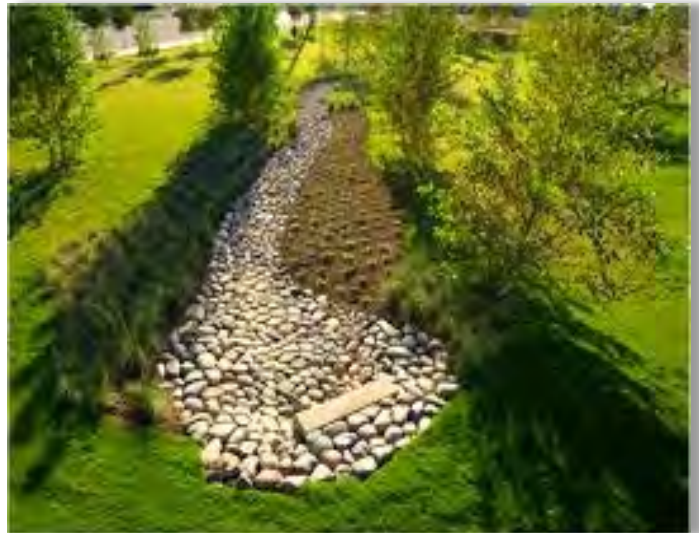
Examples of Bioswales

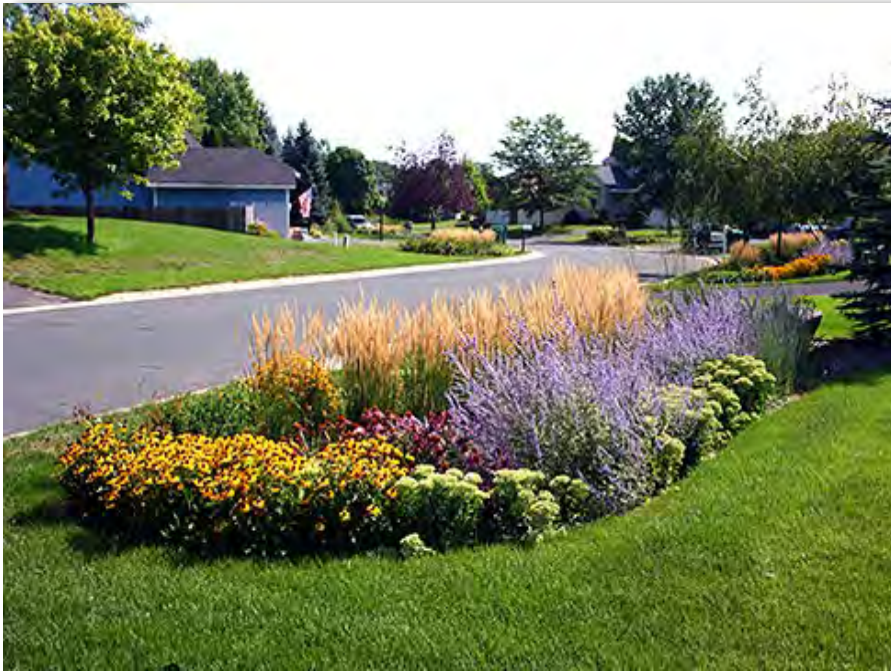
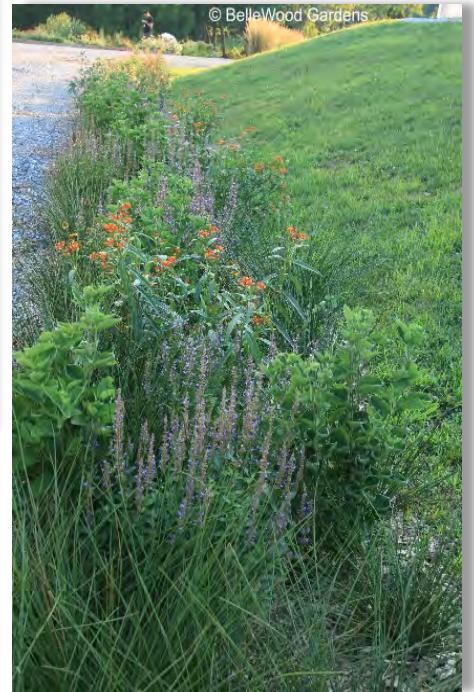
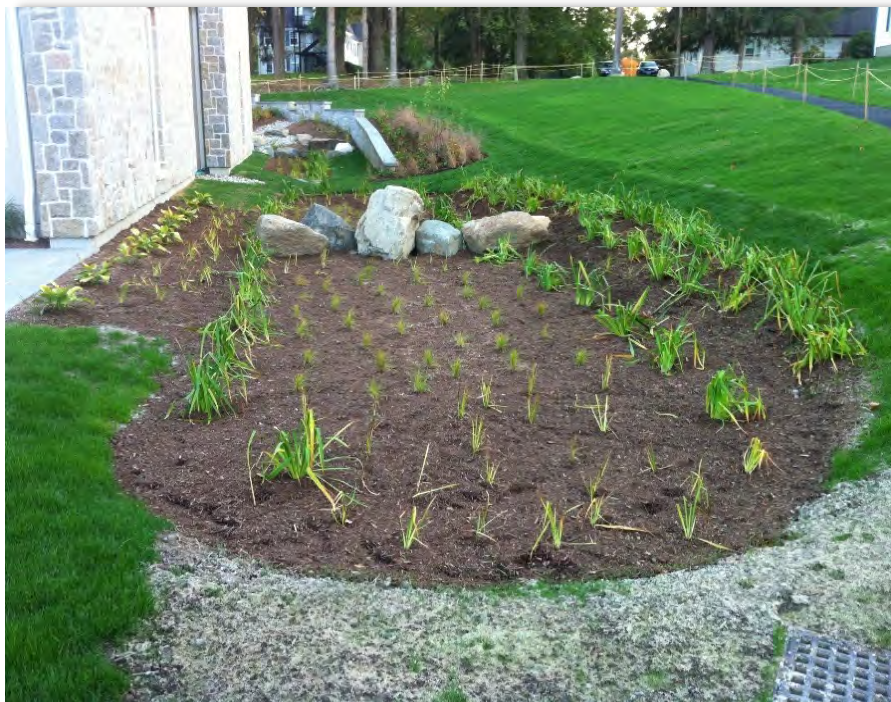
Examples of Rain Gardens

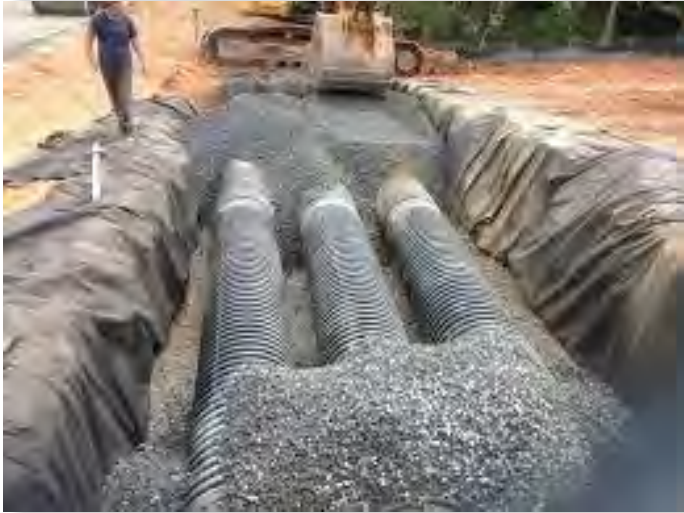
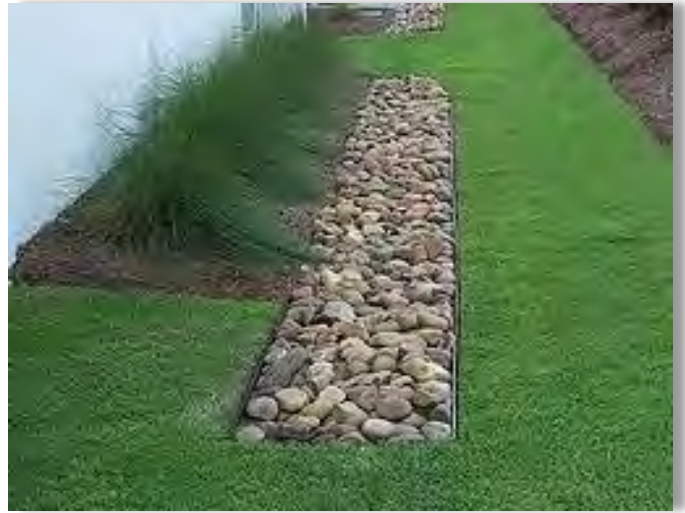
**Examples of Infiltration Galleries**
